SERVICE LIFE EVALUATION OF CORRUGATED STEEL PIPE

Storm Water Detention
Systems in the Metropolitan
Washington, DC Area

INTRODUCTION

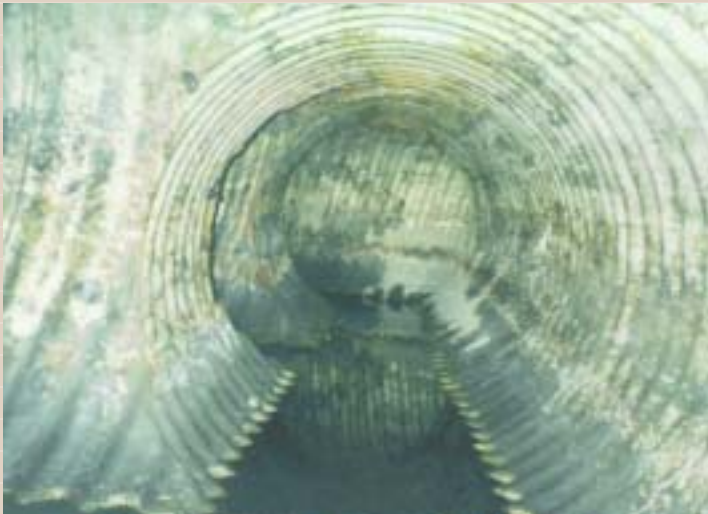
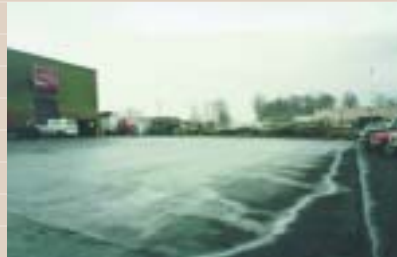
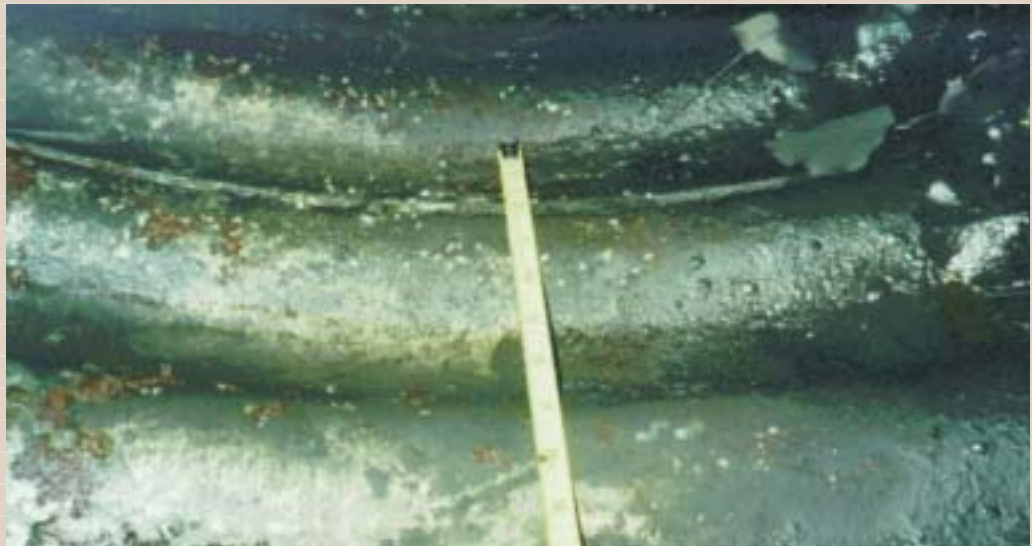
SITE 2: 48" Detention System, Montgomery County

CROWN: SOIL SIDE

INVERT: SOIL SIDE

INVERT: "SAW CUT" SOIL SIDE

CROWN: WATER SIDE

INVERT: WATER SIDE

INVERT:
"SAW CUT" WATER SIDE

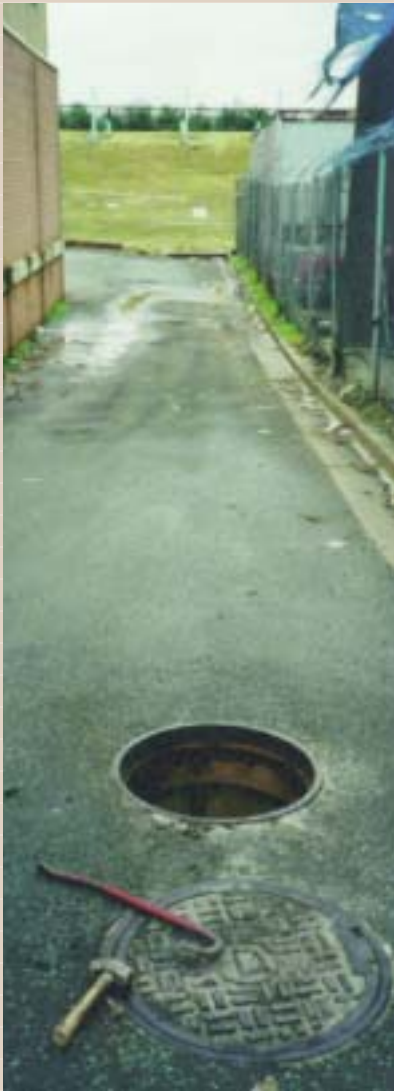
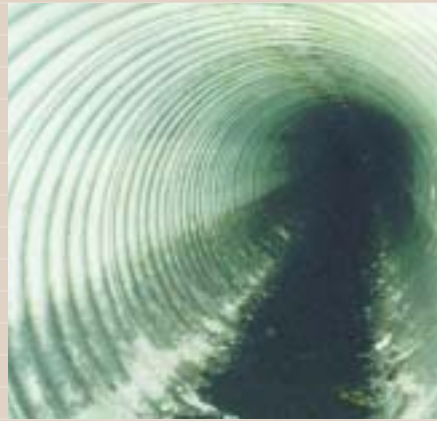
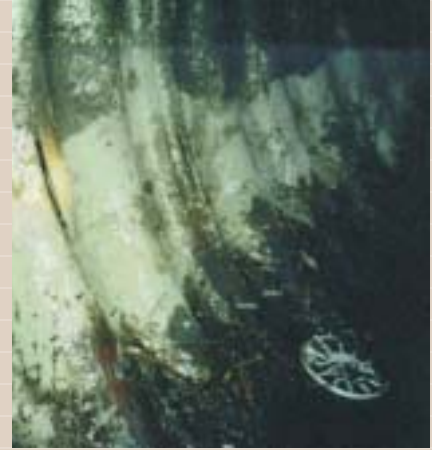
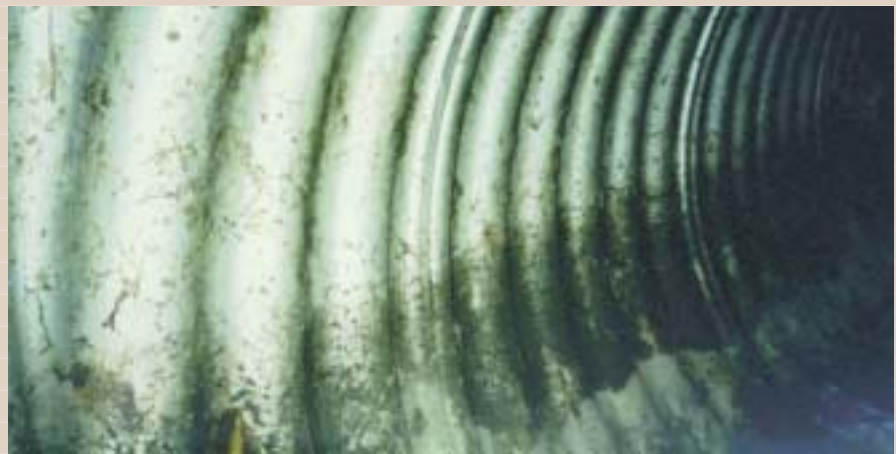
SITE 3: 48" Detention/Infiltration System, Montgomery County

CROWN: SOIL SIDE

INVERT: "SAW CUT" SOIL SIDE

CROWN: WATER SIDE

INVERT: "SAW CUT" WATER SIDE

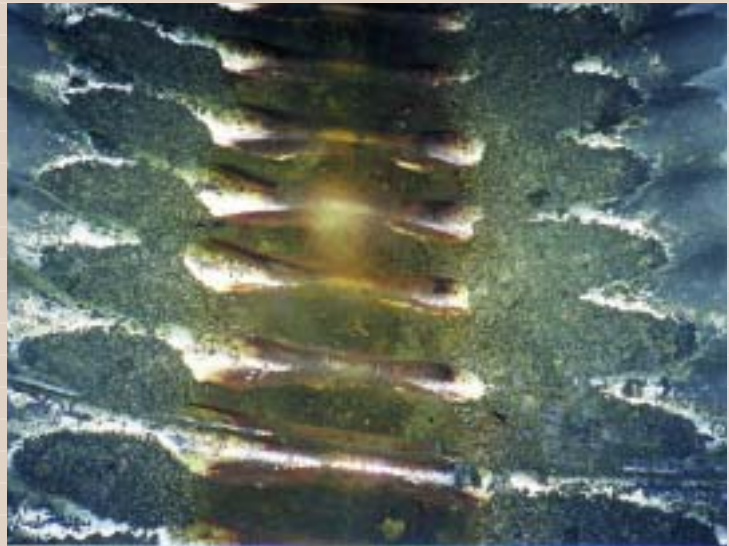
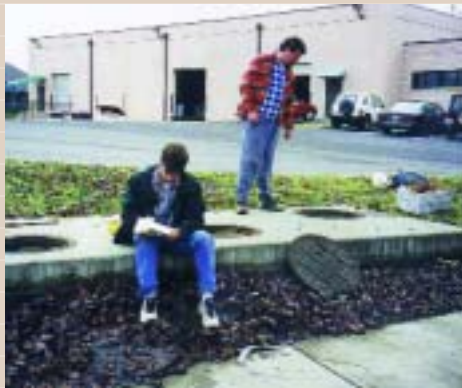
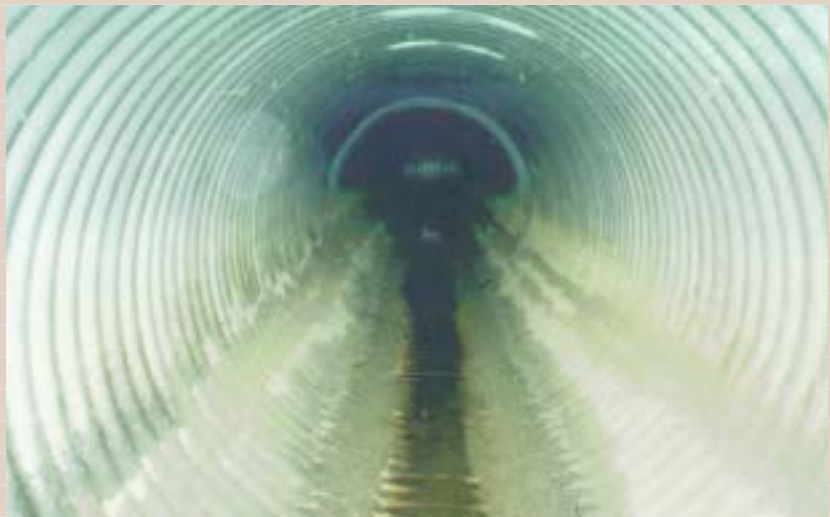
SITE 5: 60" Detention System, Montgomery County

CROWN: SOIL SIDE

INVERT: SOIL SIDE

CROWN: WATER SIDE

INVERT: WATER SIDE

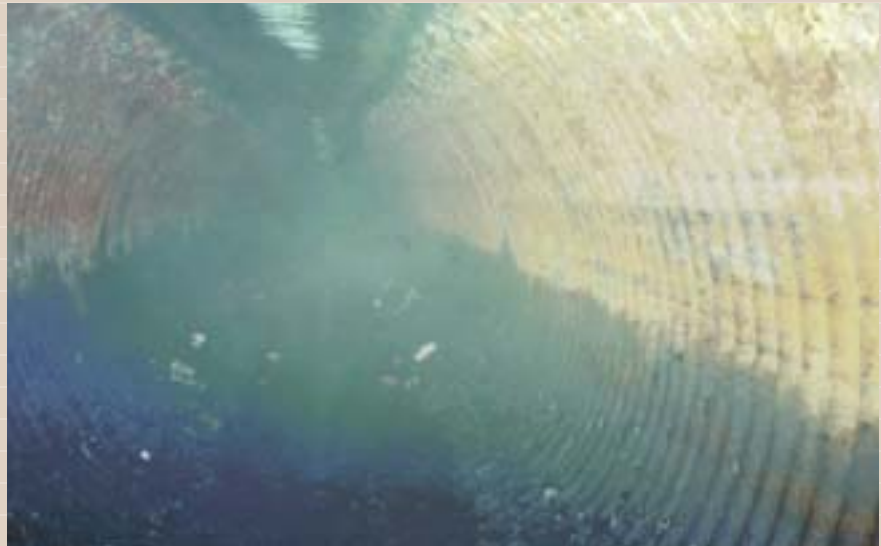
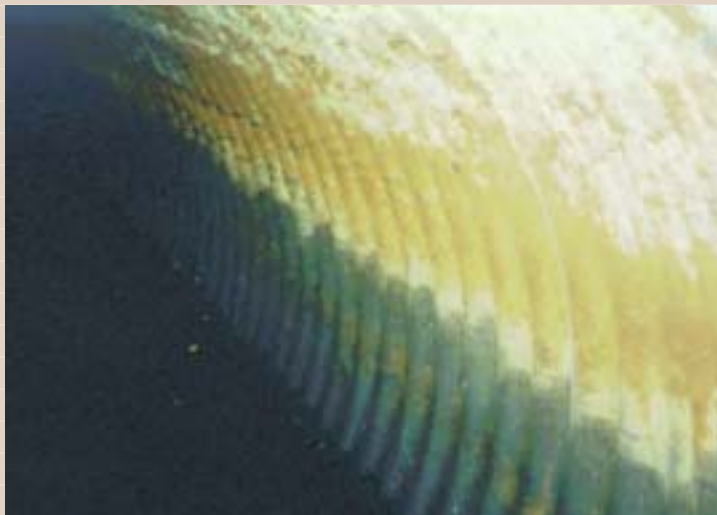
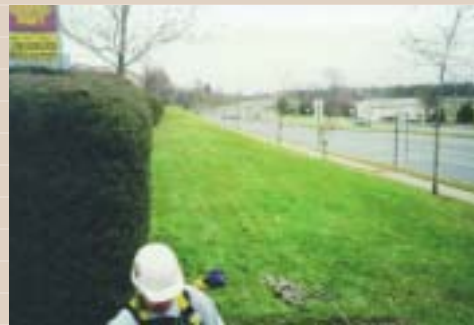
SITE 6: 96" Detention System, Montgomery County

INVERT: SOIL SIDE

CROWN: SOIL SIDE

INVERT: WATER SIDE

CROWN: WATER SIDE

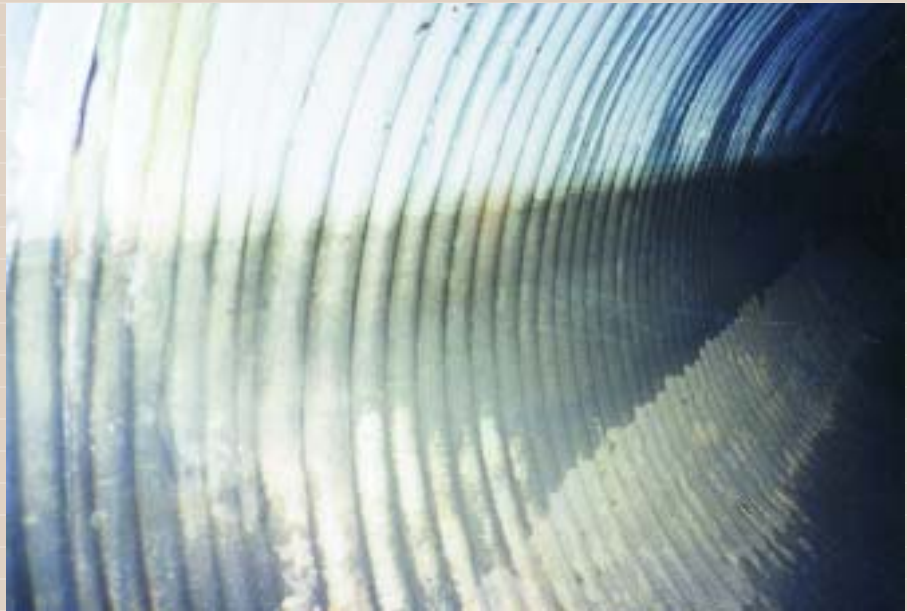
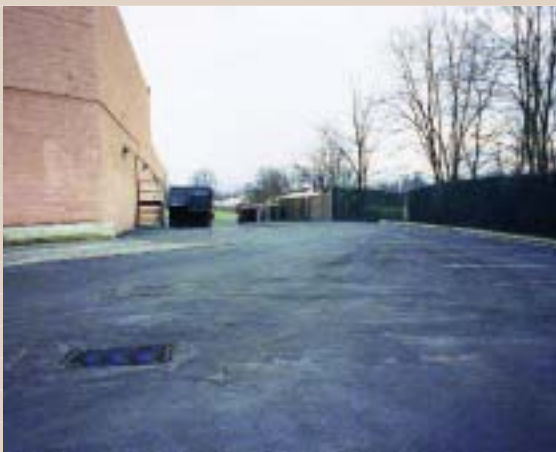
SITE 7: 96" Detention System, Montgomery County

CROWN: SOIL SIDE

INVERT: SOIL SIDE

CROWN: WATER SIDE

INVERT: WATER SIDE

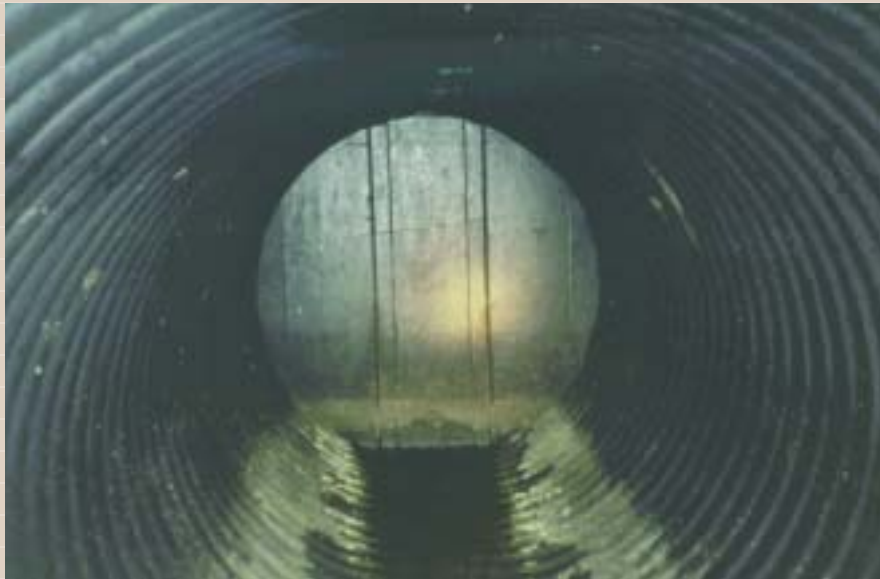
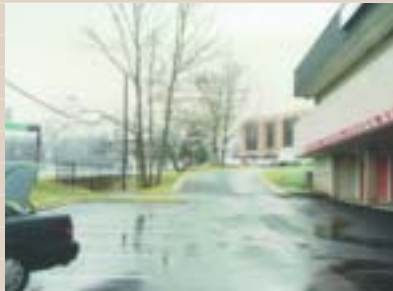
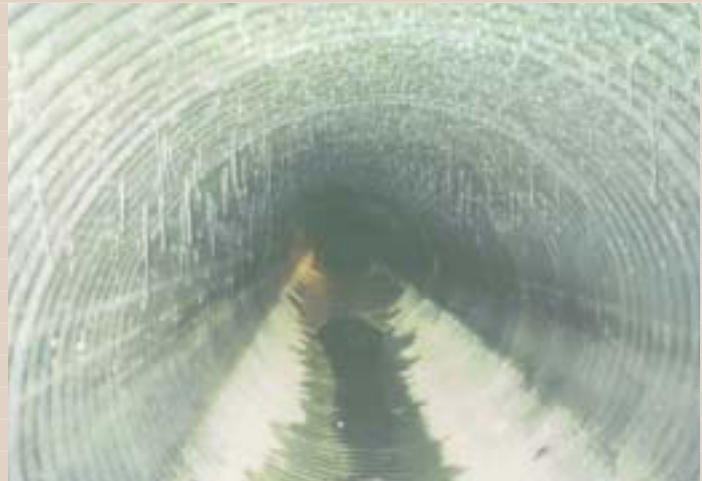
SITE 8: 72" Detention System, Montgomery County

CROWN: SOIL SIDE

INVERT: SOIL SIDE

CROWN: WATER SIDE

INVERT: WATER SIDE

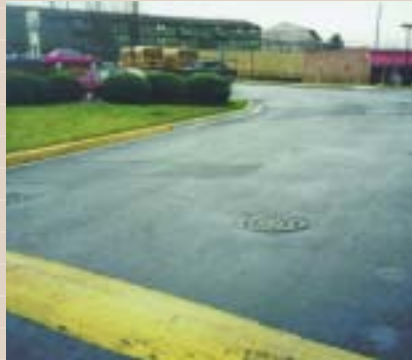
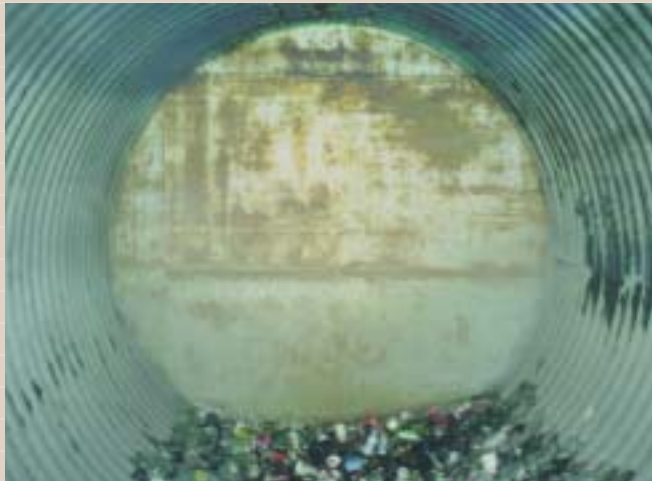
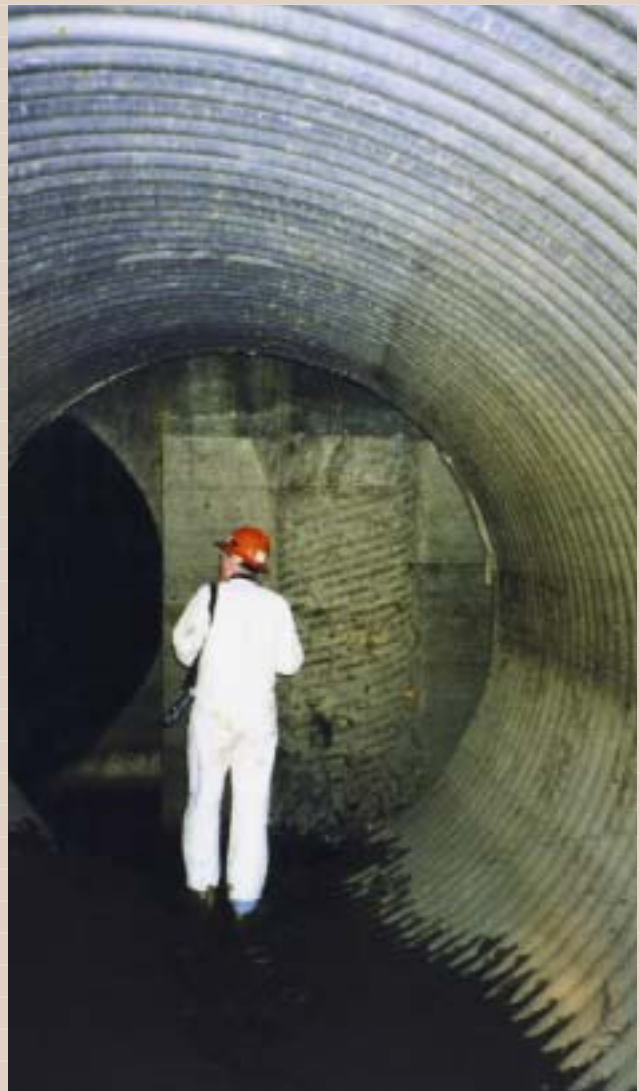
SITE 9: 108" Detention System, Montgomery County

SIDE: SOIL SIDE

INVERT: SOIL SIDE

SIDE: WATER SIDE

INVERT: WATER SIDE

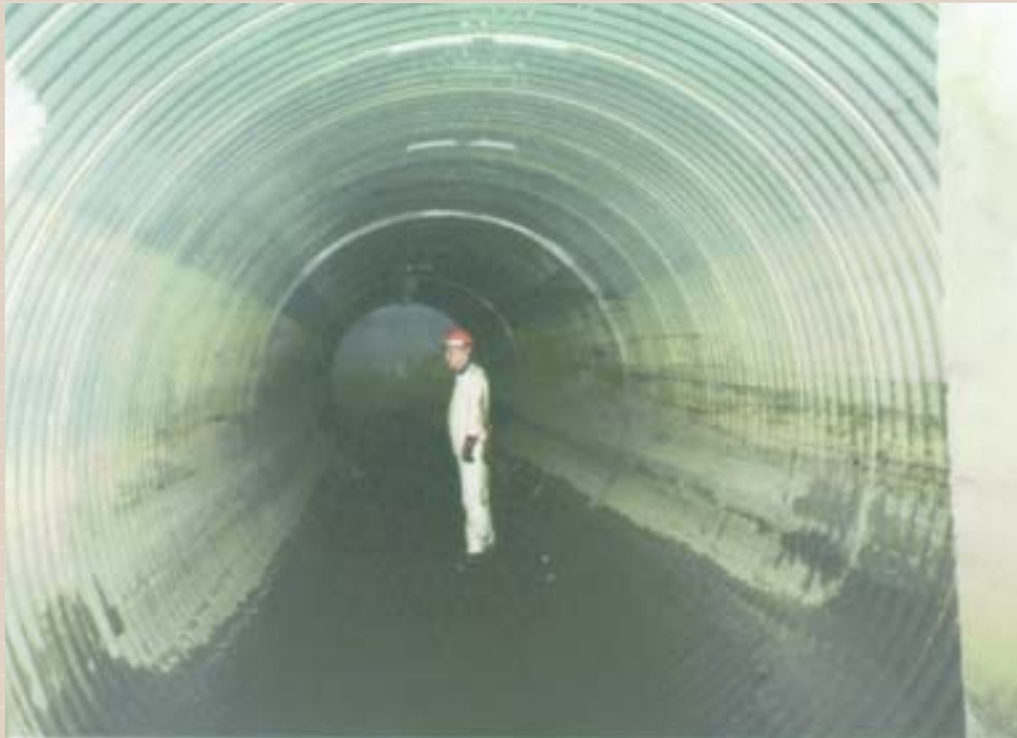
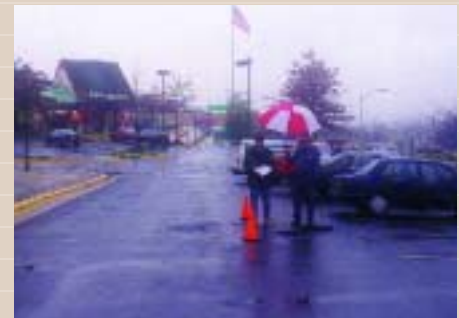
SITE 13: 108" Detention System, Montgomery County

SIDE: SOIL SIDE

INVERT: SOIL SIDE

SIDE: WATER SIDE

INVERT: WATER SIDE

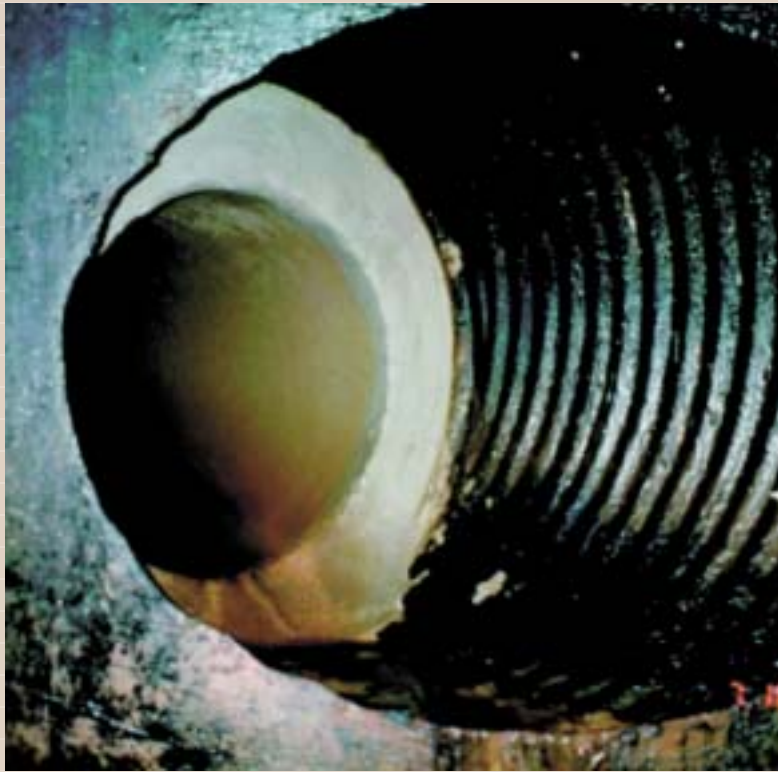
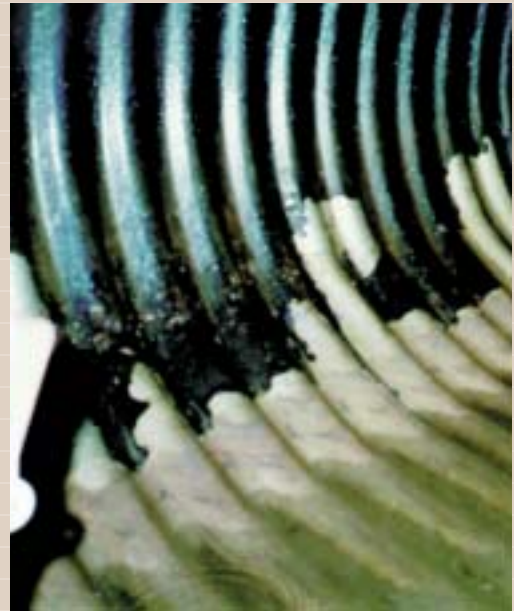
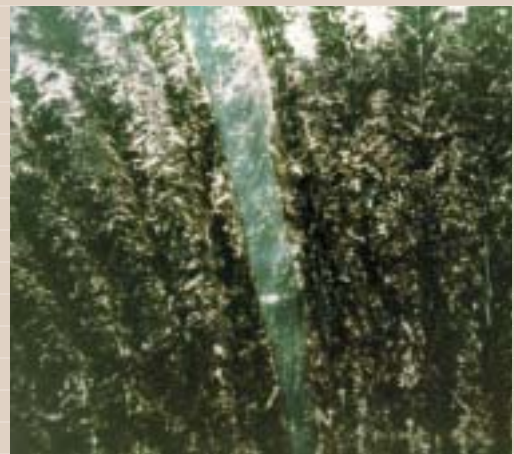
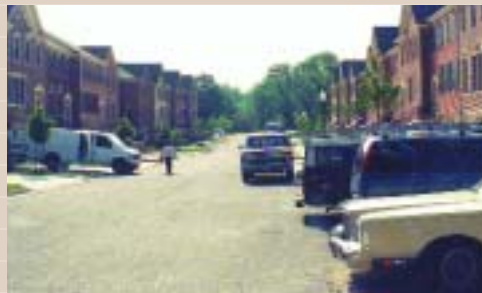
SITE 14: 67"x104" Detention System, Fairfax City

SIDE: SOIL SIDE

INVERT: SOIL SIDE

SIDE: WATER SIDE

INVERT: WATER SIDE

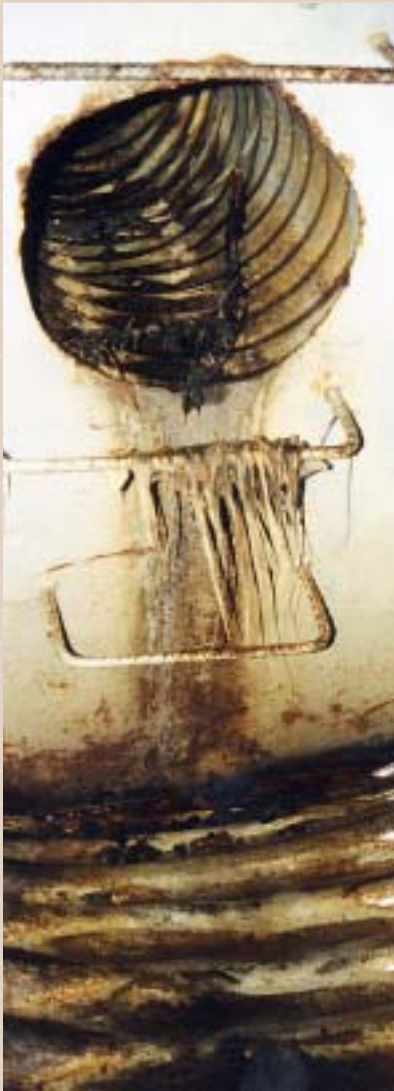
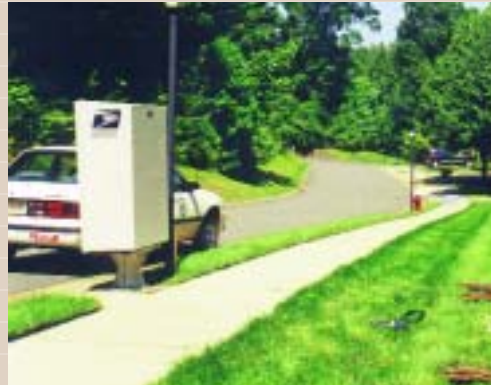
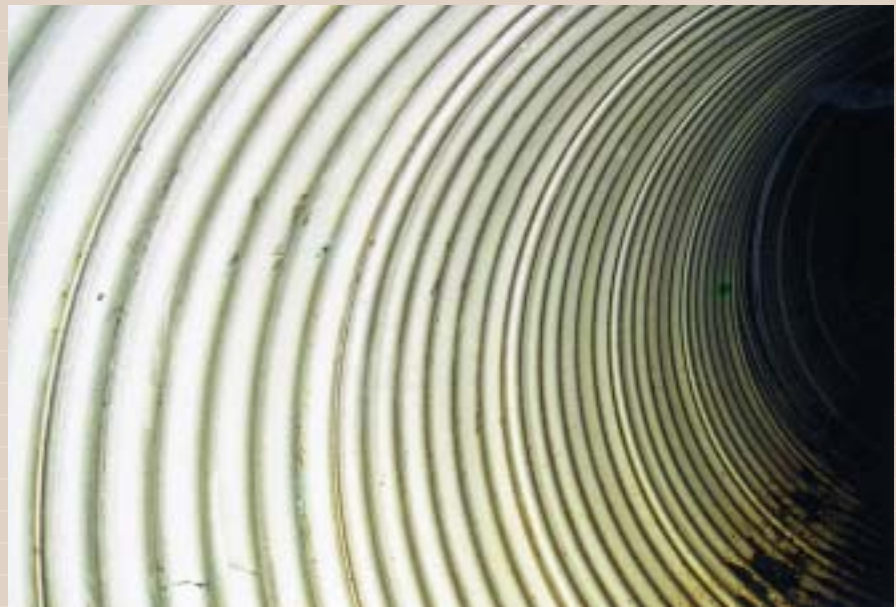
SITE 16: 80" Detention System, Fairfax City

CROWN: SOIL SIDE

INVERT: SOIL SIDE

CROWN: WATER SIDE

INVERT: WATER SIDE

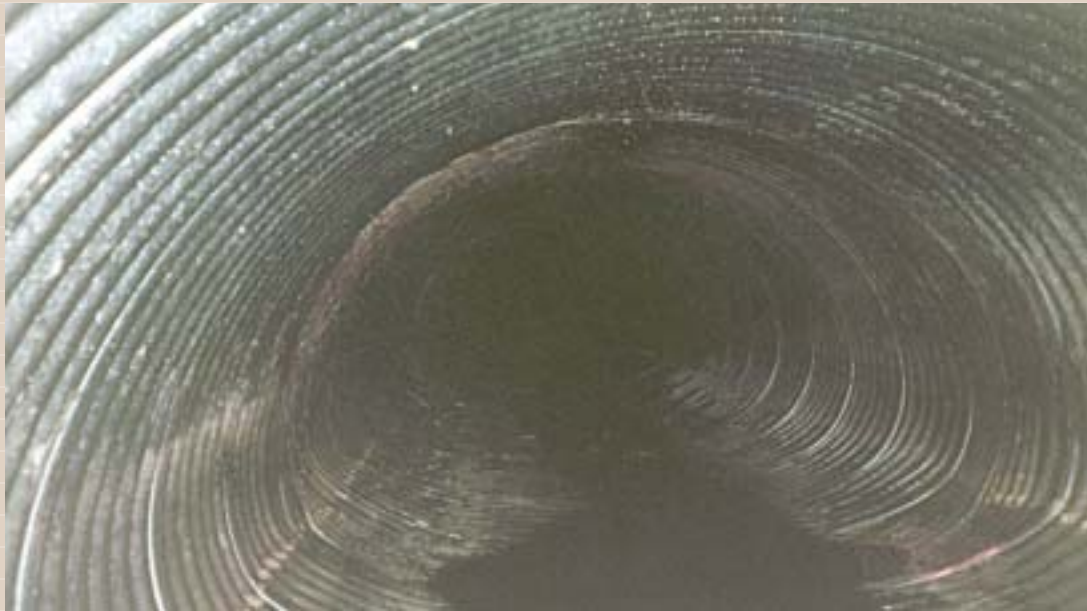
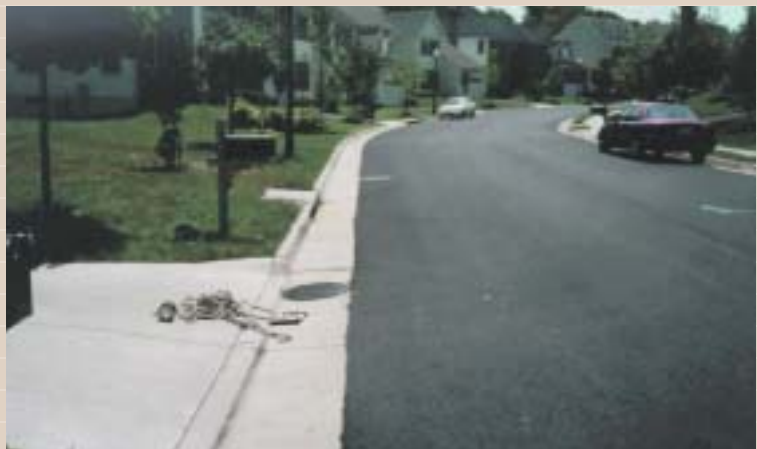
SITE 17: 65"x107" Detention System, Fairfax City

SIDE: SOIL SIDE

INVERT: SOIL SIDE

SIDE: WATER SIDE

INVERT: WATER SIDE

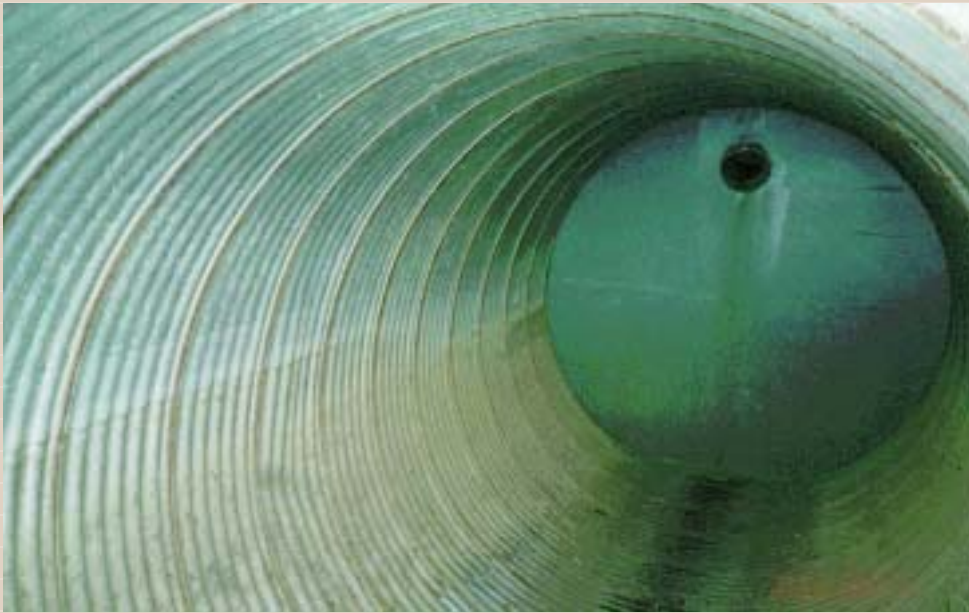
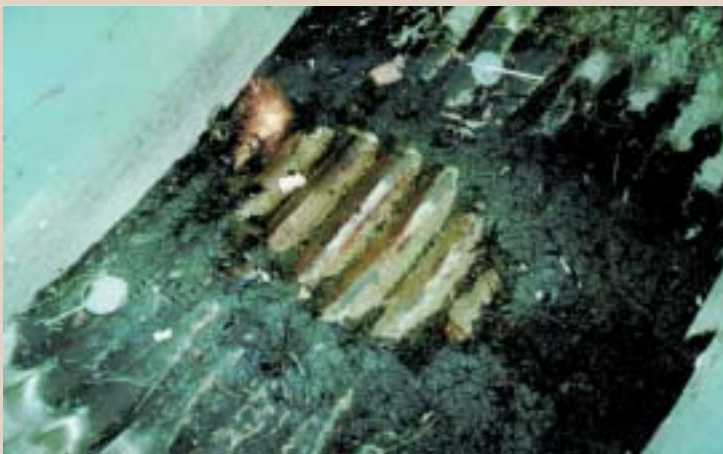
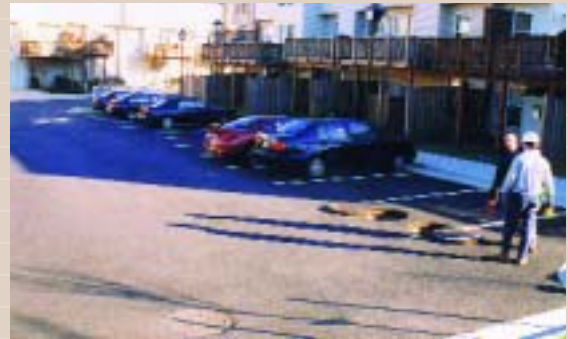
SITE 21: 72" Detention System, Alexandria

CROWN: SOIL SIDE

INVERT: SOIL SIDE

CROWN: WATER SIDE

INVERT: WATER SIDE
