CORRUGATED STEEL PIPE INSTITUTE

EXCEPTIONAL DURABILITY OF GALVANIZED CSP IN SOUTHERN MANITOBA

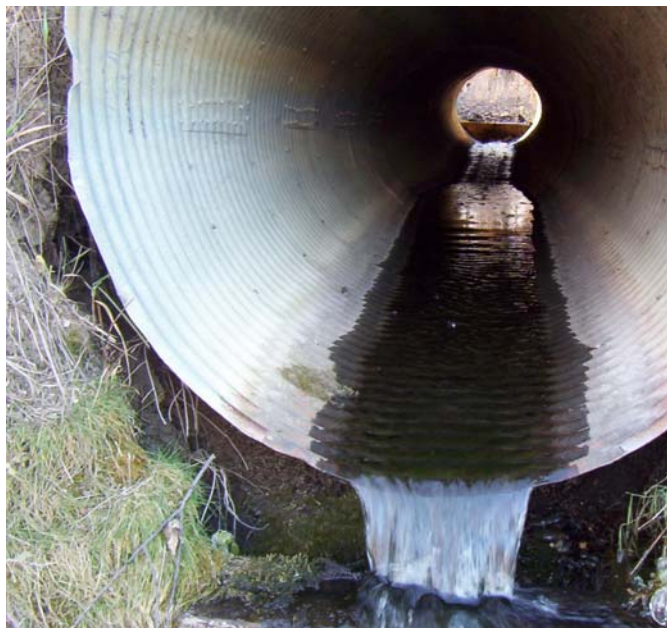
Protective Scale on Older Culvert

The key to the exceptional durability of CSP in Southern Manitoba is the water. Today's water is not unlike the hard calcium carbonate rich water that created the fossils. Calcium carbonate is naturally attracted to the zinc that coats galvanized CSP. As water flows over the pipe surface, calcium attaches itself creating a natural build up or scale. This scale locks in the zinc and at the same time protects the zinc from corrosive elements in the environment. The scale is visible as a grey crust on pipe inverts below the water line. At some older installation inspection sites, where the crust was scraped away with a knife, the zinc is still shiny.

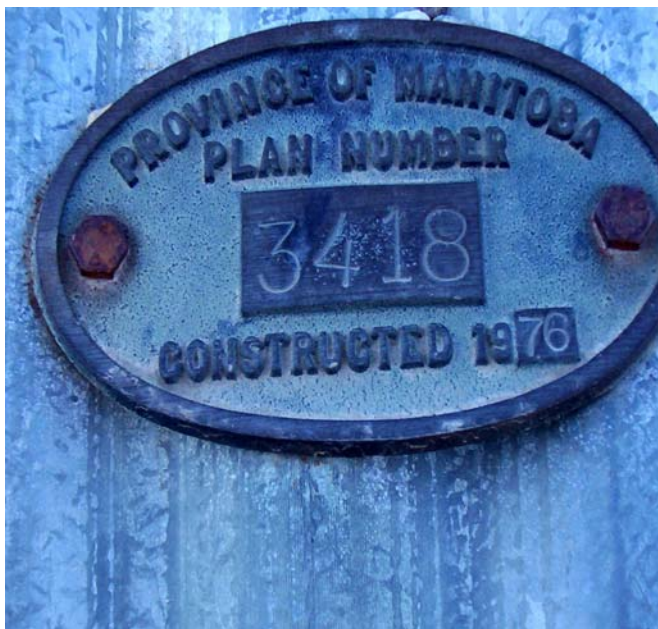
Date Plaque on Highway Culvert

Galvanized Corrugated Steel Pipe was first manufactured in Manitoba in 1908. Culverts from that era to the present remain in service and are performing well today. It is not uncommon to find old salvaged pipe reinstalled at new locations, as roads are widened and improved. Attaching date plaques to Manitoba highway culverts, started in 1950s and continues as part of an ongoing monitoring programme.
