Field Repair of Polymer Laminate Barrier Coating

Application Bulletin / DENSO Butyl 35

Denso Butyl 35 for repair of Polymer Laminated Corrugated Steel Pipe (PLCSP*)

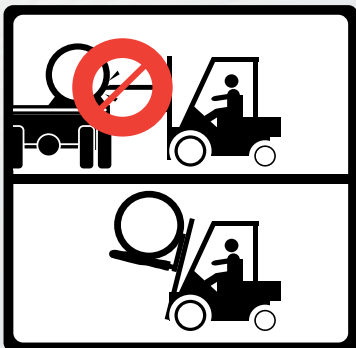
AVOID IMPACT / ÉVITER LES IMPACTS

Damage to the barrier coat can be minimized if impact and contact with hard or sharp objects is avoided.

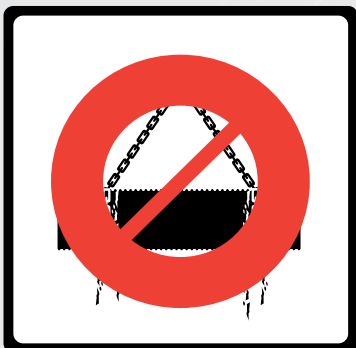
NO CHAINS/USE STRAPS
PAS DE CHÂÎNES/UTILISER
COURROIES

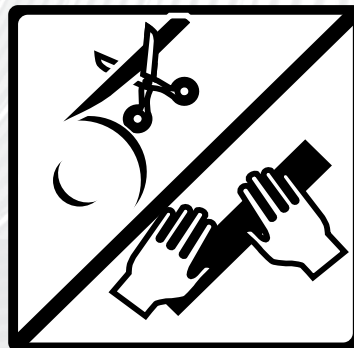
REPAIR DAMAGE/
RÉPARER LES DOMMAGES

Field repairs are best managed by applying Denso Butyl 35 Tape over any damaged area. This can be done at all temperatures and has been proven effective in a variety of construction site conditions. The tape is available from CSP manufacturers or from www.densona.com

1. With a clean cloth, wipe the damaged area removing any dirt, oil or water. Oil film can be removed with a solvent (Varsol) which should be allowed to flash off before the tape is applied. Removing surface shine with an abrasive pad (Scotch-Brite® red) will improve the bond and should be considered as an extra measure if damage is located inside the pipe and below the water flow line. No primer application is required for these repairs.
2. Cut a piece of Denso Butyl 35 tape that is large enough to cover the damaged area allowing for a minimum of 1 cm coverage of the laminate all around the damaged area.
3. Remove blue backing from tape and place black tape over the damaged area.
4. Apply finger pressure to the tape forcing air from beneath and ensuring full contact with the surface of the CSP. Tape located over a lock seam should be pressed into any grooves.
